**San Francisco Bay Living Shorelines Project
Physical Properties Report, November 2014**

Environmental Science Associates (ESA)

This report summarizes the methods and results of the physical processes studies as part of the San Francisco Bay Living Shorelines: Near-Shore Linkages Project.

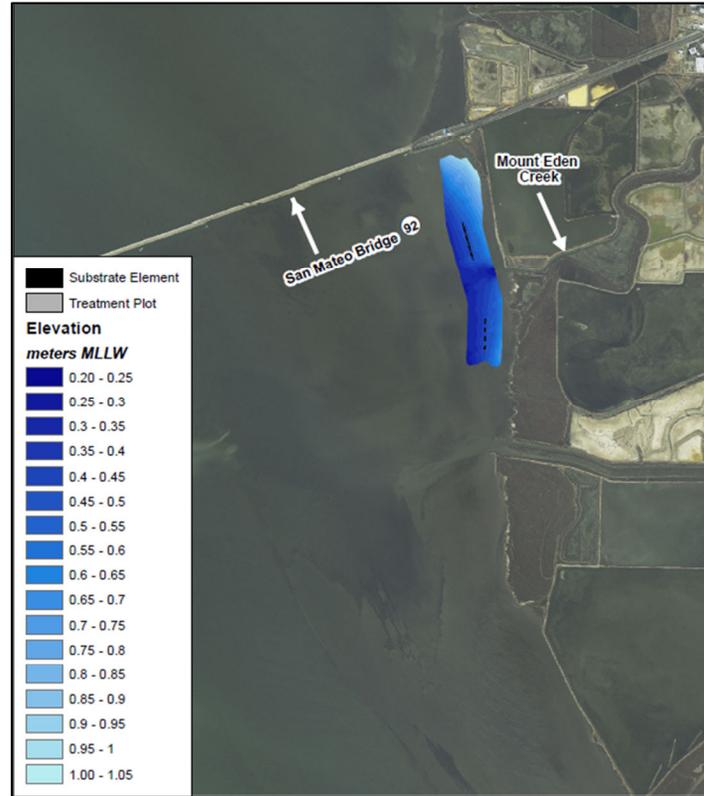
Figure 2. ELER site at Eden Landing showing the location of the substrate elements and the limits of the bathymetric survey.

is smaller in scale, consisting of replicate 1x1 m elements of different substrate types at 30m spacing placed parallel to the shore. The layout is intended to compare native oyster recruitment and growth parameters to inform the feasibility future restoration projects (Figure 2). To provide a comparison, a similar small scale “substrate element” experiment was also setup at the TNC site. A detailed description of the experimental design and construction for the TNC and ELER sites is given elsewhere in this report.

ESA PWA subcontracted Environmental Data Solutions to conduct a single-beam bathymetric survey prior to construction at the TNC site (Figure 1) and ELER site (Figure 2). The surveys, completed in May 2012, utilized Class 1 methods and accuracies as outlined in the USACE Hydrographic Surveying Manual (USACE 2002). Bathymetric data were collected using an Odom CVM survey grade fathometer with a 3-degree, 200-kHz transducer. The transducer was mounted in a fathometer well (housing a mineral oil bath) located mid-ship through the hull in the keel. Fathometer readings were oriented in space via communications with a Leica Viva Real-Time Kinematic GPS (RTK-GPS) system receiving corrections from the Leica SmartNet base station network. The survey was completed in horizontal coordinate system NAD83 State Plane Zone 3 Feet, and the vertical datum NAVD 88 Feet. The data was then provided to ESA PWA in point format. ESA PWA created a TIN surface from the point file in order to check for any survey irregularities, and then converted to a raster using the natural neighbor function. The raster was then converted to meters MLLW.

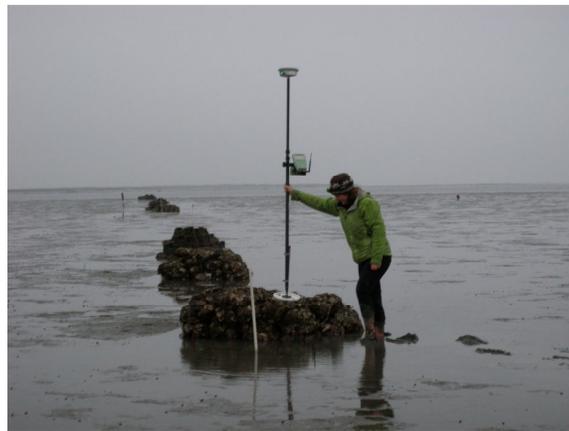
Prior projects that installed reef elements near the TNC site in San Rafael observed significant subsidence into the bed due to the muddy substrate; some settling of the individual oyster reef units would be expected as a result. To quantify this, the top elevation of selected elements at the TNC and ELER sites were measured at regular intervals to determine the rates of subsidence. An initial elevation of every element in the test plots and at least one element per shell bag unit in the larger plots was collected beginning in October 2012. A combined RTK-GPS and total station topographic survey was completed to measure the element elevation relative to a local temporary benchmark (Figure 5). The same element within a shell bag unit was tagged and surveyed each time to maintain consistency. Monthly surveys were continued until the subsidence appeared to level off, at which point collection shifted to bi-monthly and then semi-annual frequency (Table 5).

Figure 5. RTK-GPS survey of element elevation

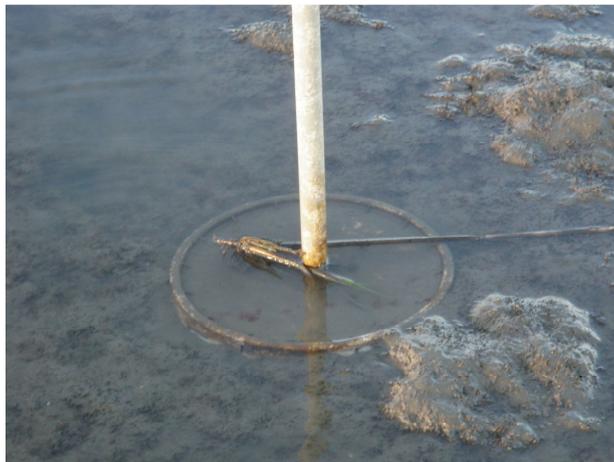
As part of the monitoring plan for sediment accretion, ESA installed 14 sediment plates immediately after the construction of the treatment plots at the San Rafael site. Sediment plates are flat disks buried in the substrate and held in place laterally by a threaded pole through the center of the plate (Figure 6). The plates were held vertically by galvanized brackets above and below the disk. Half of the plate surface was sanded to enhance sediment trapping of finer particles on a rougher surface. The sediment accretion/scour was measured monthly by taking four repeat measurements of the sediment thickness on the plate surface and averaging (Table 6). Biofouling and bed scouring became challenges for using sediment plates to the point that their use had to be discontinued after December 2012.

Figure 6. Sediment plate

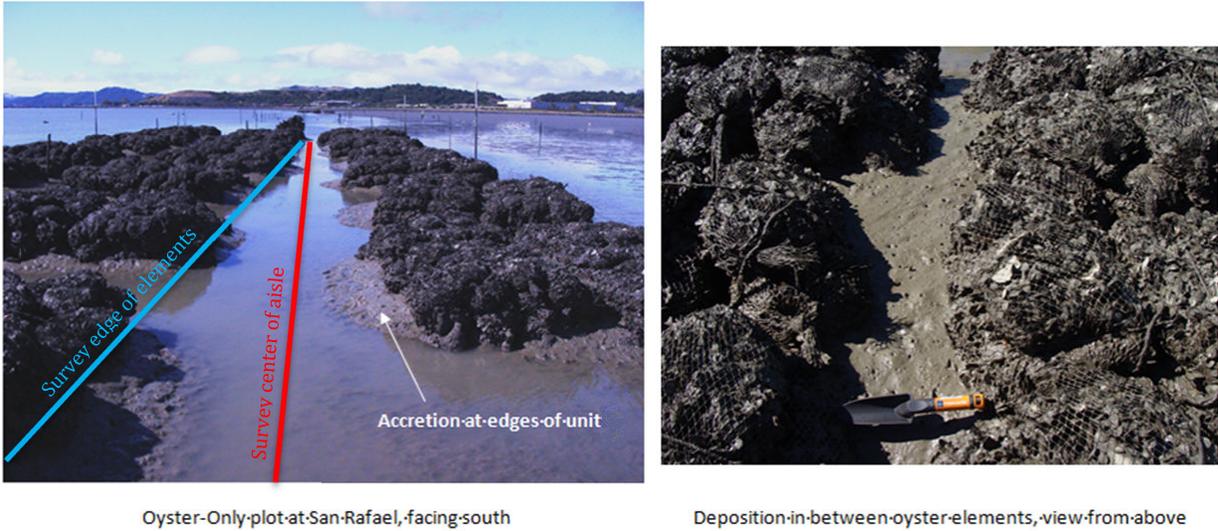
For the oyster-only and oyster-eelgrass treatment plots, one transect was collected through the middle of the aisles between elements while the second was collected close to the edge of the elements to

capture the undulations in bed topography that occur close to the individual elements (Figure 8). In the oyster-only treatment plot, data points were also collected between the shell bags in the middle of the units, where sediment has been accumulating rapidly (Figure 8).

Figure 8. Sediment bed survey types and methods for the TNC site.

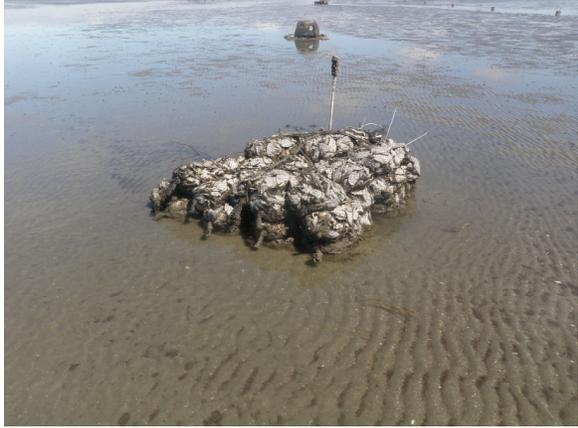
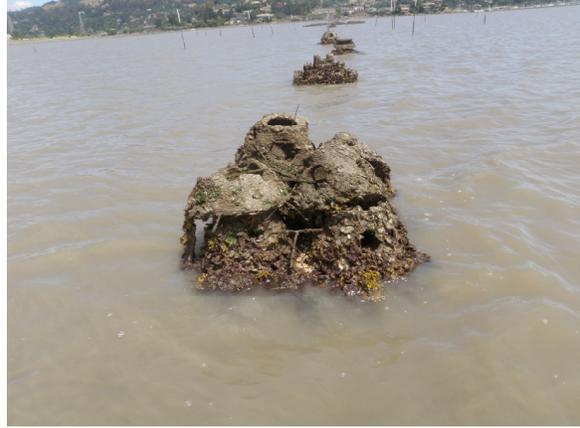
Figure 22. May 2014 photographic documentation.

Minor scour around shell bag.	Note oyster ball stack breaking apart into pieces.

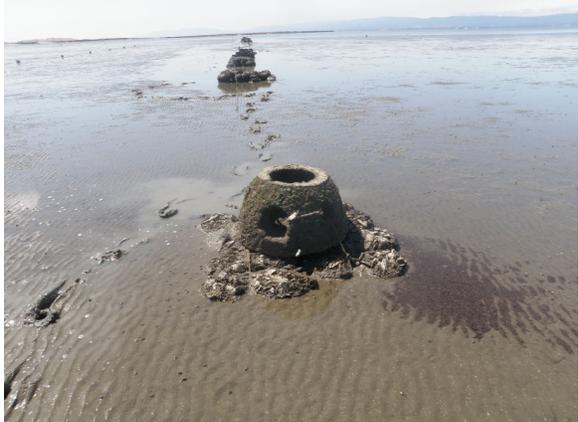
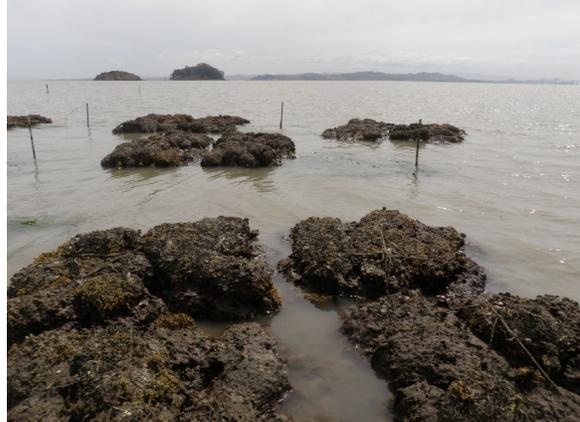
Minor sedimentation around element in foreground.	Note sediment level inside shell bags under thin layer of water. Oyster-eelgrass plot.
